**DEPARTMENT OF TRANSPORTATION**

Contract #: 04-0120F4Cty: SF/ALA Rte: 80 PM: 13.2/13.9File #: 69.28**WELDING INSPECTION REPORT****Resident Engineer:**Siegenthaler, Peter**Address:** 333 Burma Road**City:** Oakland, CA 94607**Report No:** WIR-017876**Date Inspected:** 27-Sep-2010**Project Name:** SAS Superstructure**OSM Arrival Time:** 700**Prime Contractor:** American Bridge/Fluor Enterprises, a JV**OSM Departure Time:** 1900**Contractor:** Zhenhua Port Machinery Company, Ltd (ZPMC), Changxing Island **Location:** Shanghai, China**CWI Name:** Gong Wai**CWI Present:** Yes No**Inspected CWI report:** Yes No N/A**Rod Oven in Use:** Yes No N/A**Electrode to specification:** Yes No N/A**Weld Procedures Followed:** Yes No N/A**Qualified Welders:** Yes No N/A**Verified Joint Fit-up:** Yes No N/A**Approved Drawings:** Yes No N/A**Approved WPS:** Yes No N/A**Delayed / Cancelled:** Yes No N/A**Bridge No:** 34-0006**Component:** OBG COMPONENT**Summary of Items Observed:**

## WELDING INSPECTION REPORT

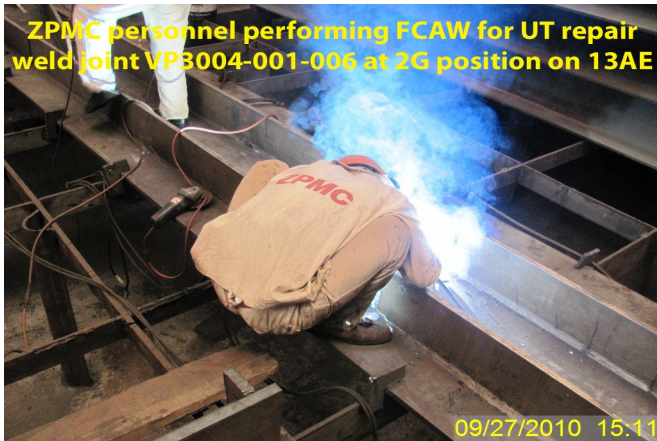
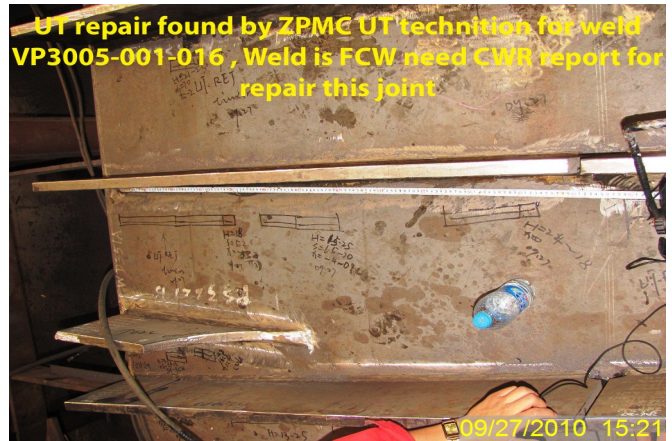
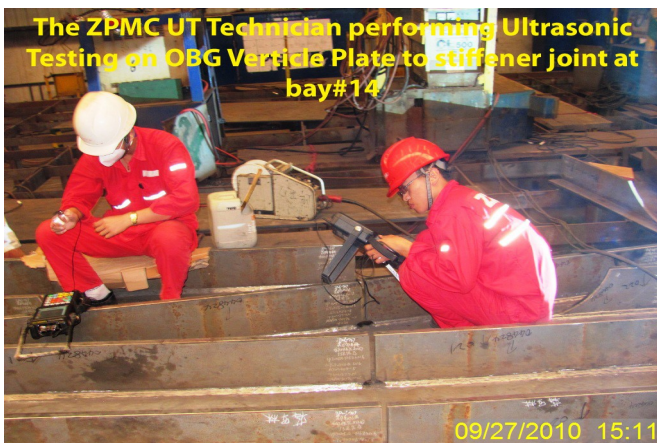
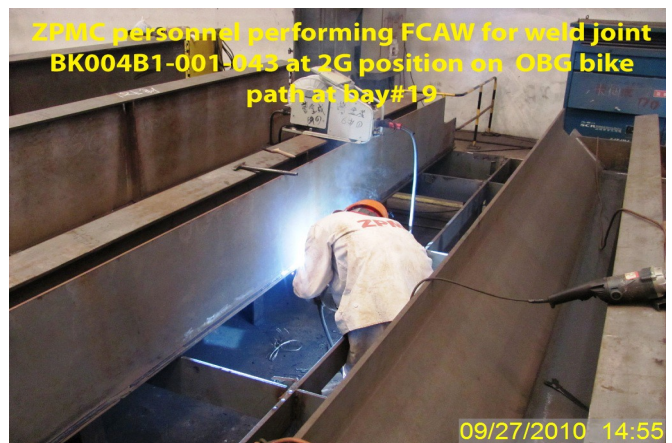
FCAW in the 2G position for the OBG segment 13CE, weld No.VP3007-001-025. The welder is identified as #067520. ZPMC QC is identified as Mr.Lv Li Qing. The welding variables recorded by QC appear to comply with WPS-B-T-2232-Tc-U4B-F.

FCAW in the 2G position for the OBG segment 14E, weld No.VP3016-001-013. The welder is identified as #066763. ZPMC QC is identified as Mr. Lv Li Qing. The welding variables recorded by QC appear to comply with WPS-B-T-2232-Tc-U4B-F.

SAW in the 1G position for the OBG segment 13BW, weld No.SEG3014-004. The welder is identified as #045270. ABF QA is identified as Mrs.Lv Yun . The welding variables recorded by QC appear to comply with WPS-B-T-2221-B-L2c-S-2.

FCAW in the 3F position for the OBG bike path, weld No. BK004A6-013-115/116. The welder is identified as #062795. ZPMC QC is identified as Mr.Xu Tao. The welding variables recorded by QC appear to comply with WPS-B-T-2133.

This Quality Assurance (QA) Inspector performed random visual inspection of OBG segment 11CE internal side panel, edge panel , bottom panel and floor beam surfaces after grit blasting in PP102 to PP103. Areas that marked for repair were recorded for future repair. Areas requiring additional grinding were marked by QA and repaired by ZPMC personnel.
